Effects of Concentrated Hydrochloric Acid Spills on Aircraft Aluminum Skin

July 1998

DOT/FAA/AR-TN97/108

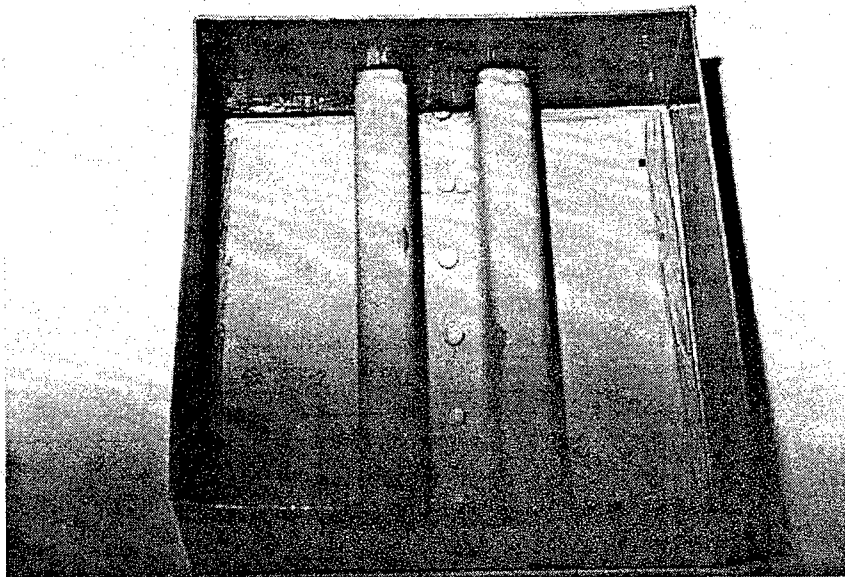
FIGURE 4. TEST ARTICLE FOR TEST 3 PRIOR TO ACID SPILL

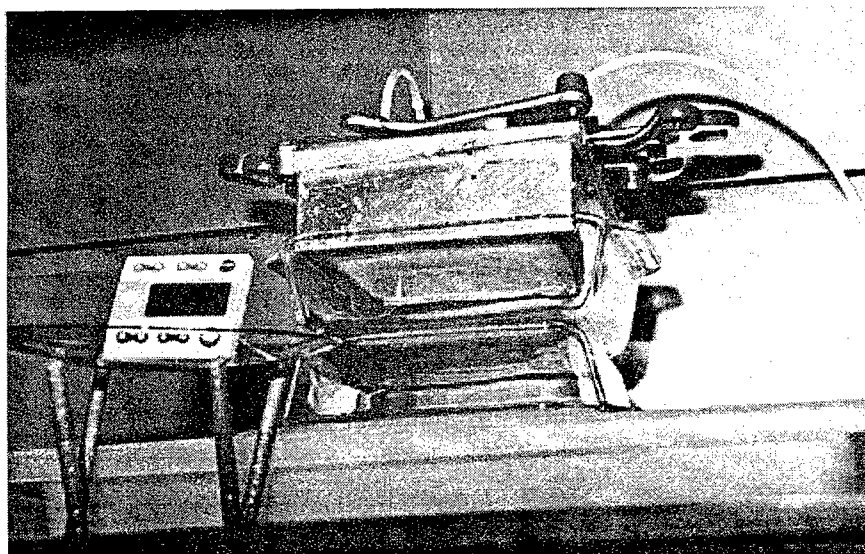
FIGURE 5. TEST 3 IN PROGRESS WITH A 1-LITER SPILL OF CONCENTRATED HYDROCHLORIC ACID

A 2.5 psi box pressure simulates the ΔP_{skin} at 15,000 feet altitude. A small ΔP may result in the blowout of the white exterior epoxy paint on the bottom of the box when the rivets fail, giving a visual indication of failure. However, the silicone lid seal failed early into the test and pressure fell to ambient.
